Manhole Inspection Summary

Manhole # S47I__035MH

Location Address: **416 portual st**

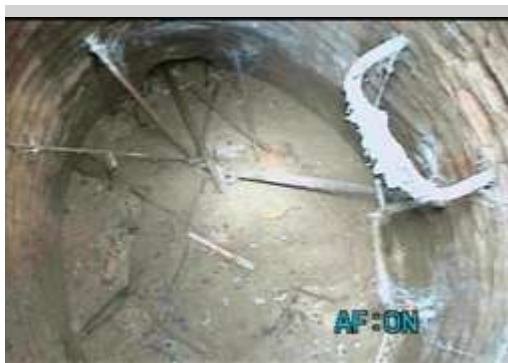
Defect 3

Condition: ☐ Sound ☐ Cracked ☐ Root Intrusion ☐ Deteriorated ☐ Leaks ☒ **Debris**

channel debris

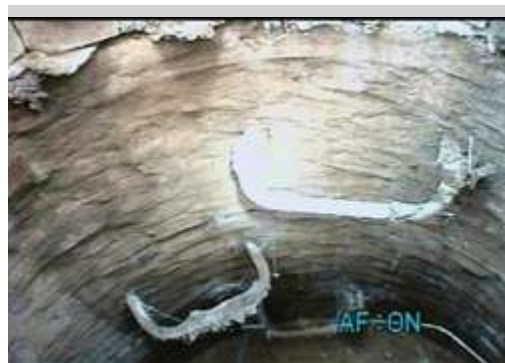
Defect 2

Steps Count: **3** Missing: **0** ☒ **Corroded**

corroded stairs

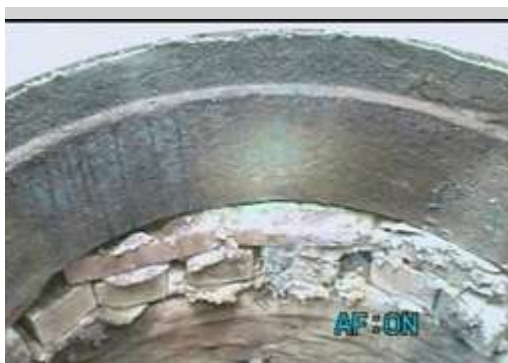
Defect 1

Condition: ☐ Sound ☐ Cracked ☐ Root Intrusion ☒ **Loose Brick** ☐ Deteriorated

loose brick chimney frame adjustment

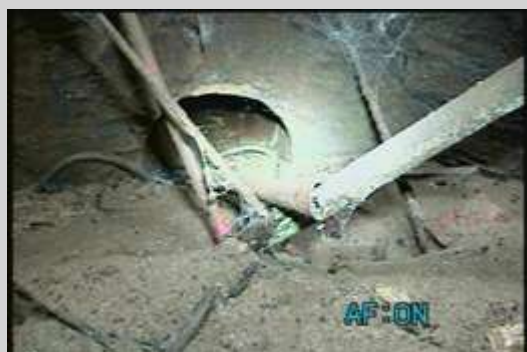
12 O'Clock Outflow

Deposits: ☐ None ☐ Mud ☐ Sludge ☒ **Debris** ☐ Grease

Silt Depth: **3** (in.) Deposits Extent: **Medium**
